**Flood Control Project Maintenance
Levee Inspections**

Maintenance Issue Types Only, Levee Inspection Report By Mile - Fall 2014

City of Sacramento

Waterway	Bank	Unit Miles	Inspection Start/End	Inspector
Unit No. 01 Sacramento River	Left	3.67	11/04/2014 11/04/2014	Clay Thomas

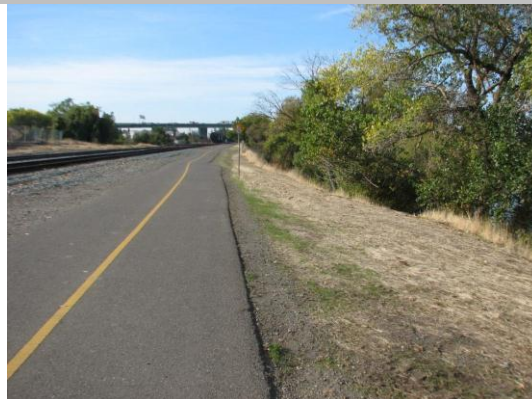
Photo 1 of 1 : FA_2014_NA0005_251_82_20141106_00033.jpg

LM Start	0.00	Rating **	A	Issue No.	82
LM End	3.63	Issue Type +	Ma	Location *	WS
Category	Earthen Levee			GPS Latitude/Longitude	
				Start	End
Item	Vegetation				°
					°
DWR ID	DWR_NA0005_01_f_2014_82				
Action/Comments					
Control annual grass and weeds on the levee slopes and easements.

Levee mile 1017, vegetation on the water side levee slope, railroad tracks on the land side slope. Fall 2014.

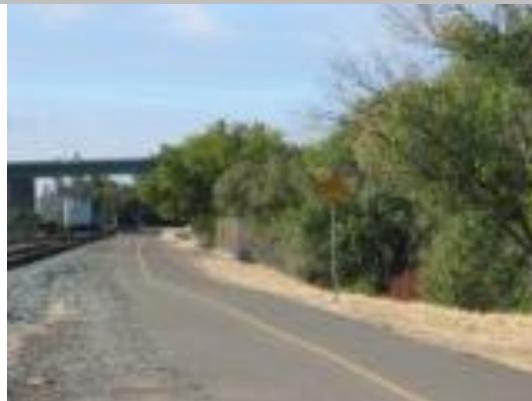
Photo 1 of 3 : FA_2014_NA0005_251_13_20141014_00014.jpg

LM Start	1.15	Rating **	A/W	Issue No.	13
LM End	1.69	Issue Type +	Ma	Location *	WS
Category	Earthen Levee			GPS Latitude/Longitude	
				Start	End
Item	Vegetation			38.574780 °	38.568757 °
				-121.510191 °	-121.515930 °
DWR ID	DWR_NA0005_01_f_2012_13				
Action/Comments					
Trees / Woody Vegetation

Trees and brush are larger than 2 inches but does not effect visibility. Photo fall 2012.

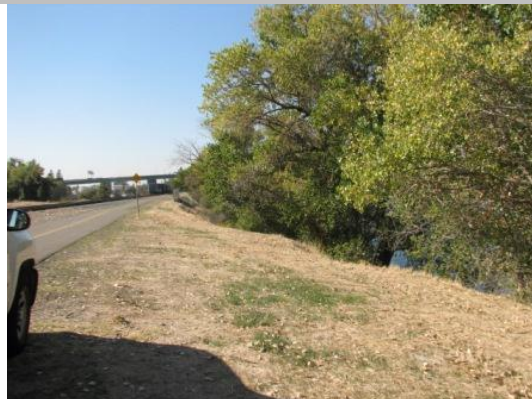
Photo 3 of 3 : FA_2014_NA0005_251_13_20141014_00016.jpg

LM Start	1.15	Rating **	A/W	Issue No.	13 (cont)
LM End	1.69	Issue Type +	Ma	Location *	WS
Category	Earthen Levee			GPS Latitude/Longitude	
				Start	End
Item	Vegetation			38.574780 °	38.568757 °
				-121.510191 °	-121.515930 °
DWR ID	DWR_NA0005_01_f_2012_13				
Action/Comments					
Trees / Woody Vegetation

Monitor the trees and woody vegetation along the rivers edge. Fall 2013

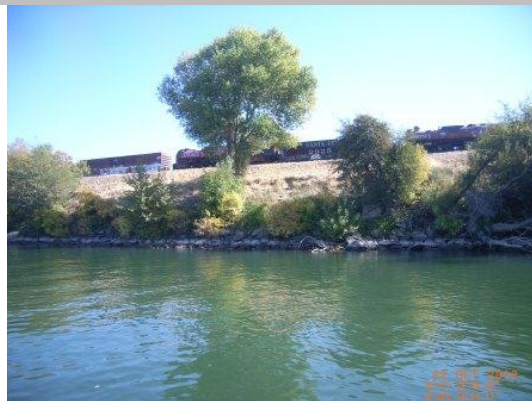
Photo 1 of 2 : FA_2014_NA0005_251_12_20141014_00012.jpg

LM Start	1.31	Rating **	M	Issue No.	12
LM End	1.39	Issue Type +	Ma	Location *	WS
Category	Supplemental			GPS Latitude/Longitude	
				Start	End
Item	USACE Erosion Survey			38.573169 °	38.572277 °
				-121.511998 °	-121.513063 °
DWR ID	DWR_NA0005_01_f_2014_12				
Action/Comments					
Inspector Comments: 2008 - Oversized levee, should be repaired under maintenance. 2009 - Shallow slumps at the mid bank. 2010 - Some minor erosion at the toe, likely from wave wash. Some new shallow slumps. 2011 - One new tree has fallen. 2013: Erosion continues on the slope surface, site extended upstream [2013 Site ID: SAC_58-5_L]

USACE 2013 Photo #1

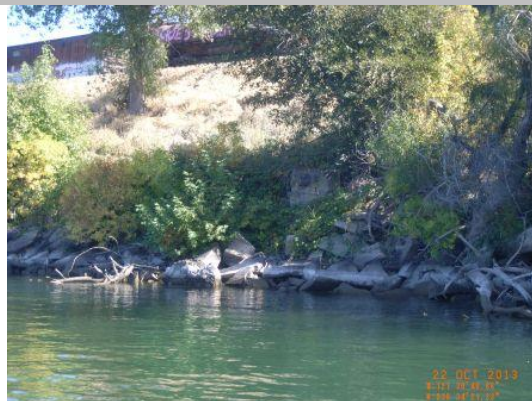
Photo 2 of 2 : FA_2014_NA0005_251_12_20141014_00013.jpg

USACE 2013 Photo #2

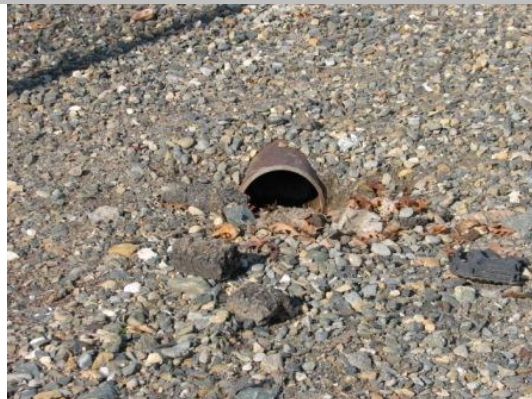
Photo 1 of 2 : FA_2014_NA0005_251_144_20141014_00024.jpg

LM Start	1.75	Rating **	A/W	Issue No.	144
LM End	1.75	Issue Type +	Ma	Location *	CR
Category	Earthen Levee			GPS Latitude/Longitude	
				Start	End
Item	Encroachments			38.567821 °	38.567821 °
				-121.516091 °	-121.516091 °
DWR ID	DWR_NA0005_01_s_2012_144				
Action/Comments					
Pipe

This appears to be a drain pipe under a driveway. It is a different pipe then the other photo for this issue. Fall 2011

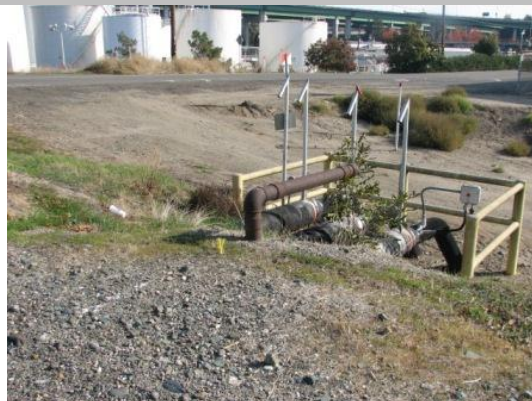
Photo 2 of 2 : FA_2014_NA0005_251_144_20141014_00025.jpg

A pipe on the landside shoulder crosses under the railroad tracks. Fall 2011

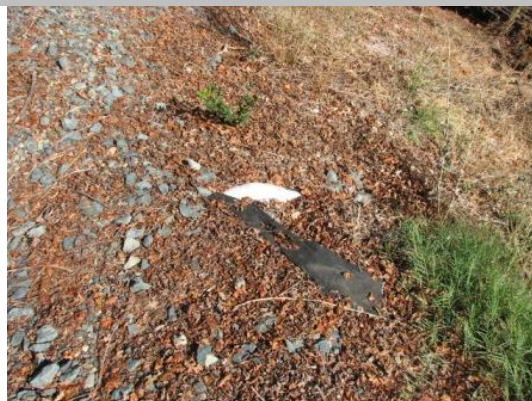
Photo 1 of 1 : FA_2014_NA0005_251_145_20141014_00026.jpg

LM Start	2.04	Rating **	A/W	Issue No.	145
LM End	2.04	Issue Type +	Ma	Location *	CR
Category	Earthen Levee			GPS Latitude/Longitude	
				Start	End
Item	Encroachments			38.563720 °	-121.515890 °
				38.563720 °	-121.515890 °
DWR ID	DWR_NA0005_01_s_2012_145				
Action/Comments					
Pipe					
Inspector Comments: The pipe has been repaired by the LMA. The pipe was installed by the Railroad Museum and is in talks with the CVFPB. No permit was issued for them.

The pipe is a french drain under the railroad tracks. Was in the USACE report has not been resolved. Photo fall 2012.

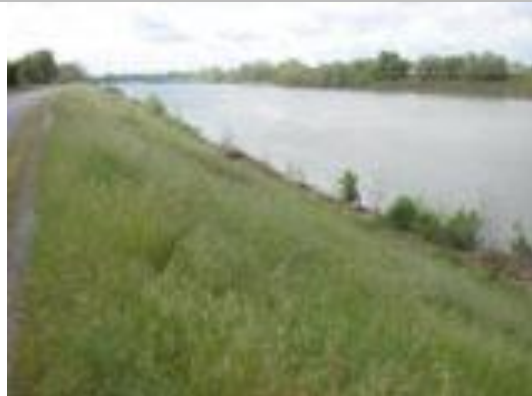
Photo 1 of 2 : FA_2014_NA0005_251_21_20141014_00021.jpg

LM Start	2.46	Rating **	A/W	Issue No.	21
LM End	2.76	Issue Type +	Ma	Location *	WS
Category	Earthen Levee			GPS Latitude/Longitude	
				Start	End
Item	Vegetation			38.557828 °	38.553710 °
				-121.514193 °	-121.512863 °
DWR ID	DWR_NA0005_01_s_2012_21				
Action/Comments					
Environmental Requirements.

A photo of the revegetation site taken spring 2012.

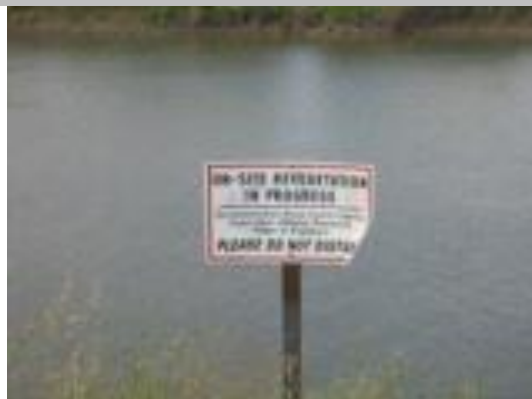
Photo 2 of 2 : FA_2014_NA0005_251_21_20141014_00022.jpg

This area is a revegetation site, photo taken spring 2012.

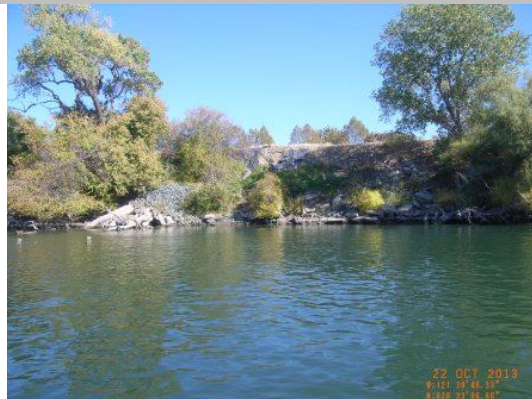
Photo 1 of 1 : FA_2014_NA0005_251_11_20141014_00011.jpg

LM Start	2.84	Rating **	M	Issue No.	11
LM End	2.84	Issue Type +	Ma	Location *	WS
Category	Supplemental			GPS Latitude/Longitude	
				Start	End
Item	USACE Erosion Survey			38.551578 °	38.552268 °
				-121.512336 °	-121.512590 °
DWR ID	DWR_NA0005_01_f_2014_11				
Action/Comments					
Inspector Comments: 1997 - Erosion at pump station, concrete debris and plastic showing. 2000 - Separation scour of bank due to poor transition. 2004 - New large tree pop out; city dumped fill dirt/rock into hole. 2006 - Minor new erosion at top of bank. 2010 - Some new rock placed in tree pop-out. 2011 - A large tree has fallen and flood fighting was performed by the city on the upper levee slope. 2012 - Small rock

USACE 2013 Photo #1
